HMS ROYAL OAK

HMS Royal Oak 80 Survey

**Ordnance, Munitions
& Torpedo Damage**

David Crofts MSc CEng FRAeS

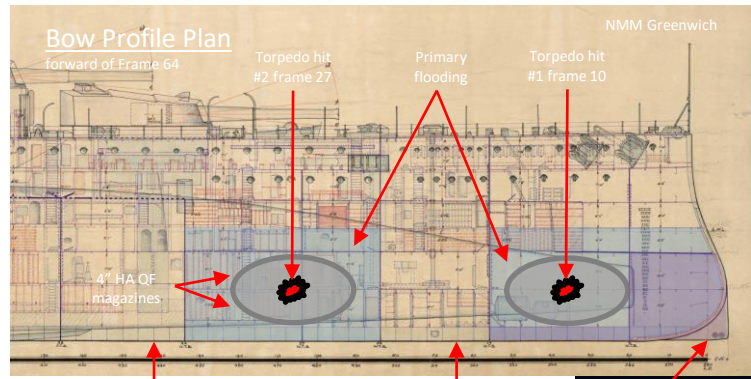
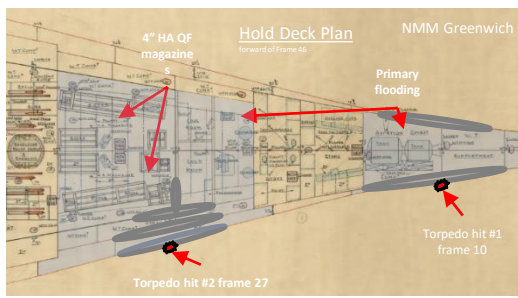
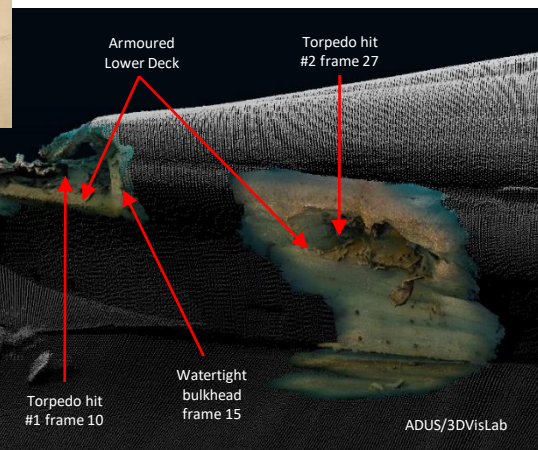
Torpedo Hits #1 and #2

Hit #1 opened the flammables & aviation fuel stores to the sea (~230 tons flooding) and caused a hole from starboard to port side.

- Since the sinking the bow forefoot has broken off and fallen to the sea bed.
- The crew mistook the torpedo hit to be an accidental explosion in the flammables store.

Hit #2 opened 4" HA QF magazine refrigeration store and torpedo head magazine to the sea (~1670 tons flooding) and breached the torpedo bulge & longitudinal armoured bulkhead.

- Damaged 4" HA QF ammunition boxes can be seen inside the magazine through the cracked bulkhead.
- Robust construction of ammunition prevented catastrophic explosion.

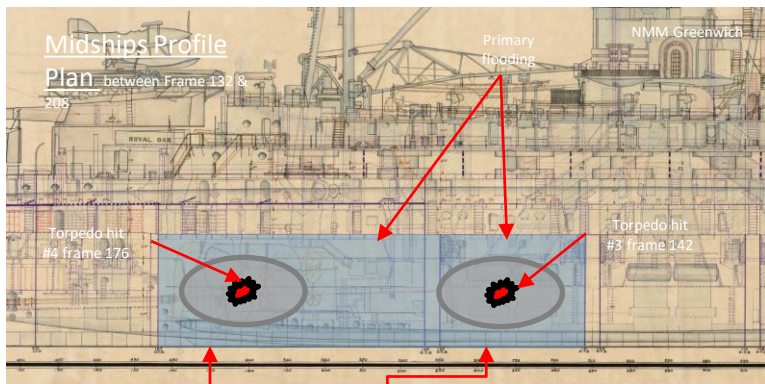
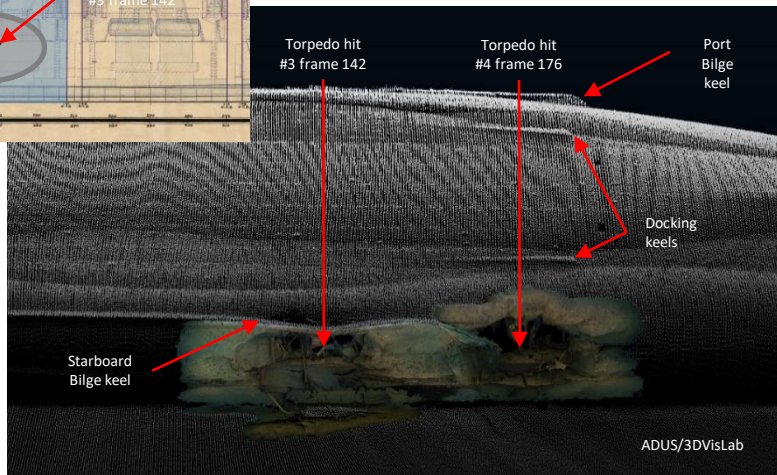
Torpedo Hits #3 and #4

Hit #3 breached the torpedo bulge, hull side, fuel tank divisions and armoured bulkhead, opening boiler room 3 to the sea (~2830 tons flooding).

- Flooding would have taken less than 2 minutes.
- Ventilators, uptakes, open hatches and cracked plating vented blast & flash onto mess decks above.
- Fuel oil would have been released into the sea.

Hit #4 breached the torpedo bulge, hull side, fuel tank divisions and armoured bulkhead, opening starboard wing engine room to the sea (~1470 tons flooding).

- Flooding would have taken less than a minute and caused an immediate list to Starboard
- As with Hit #3 blast & flash would have vented onto mess decks above, and fuel oil released into the sea.

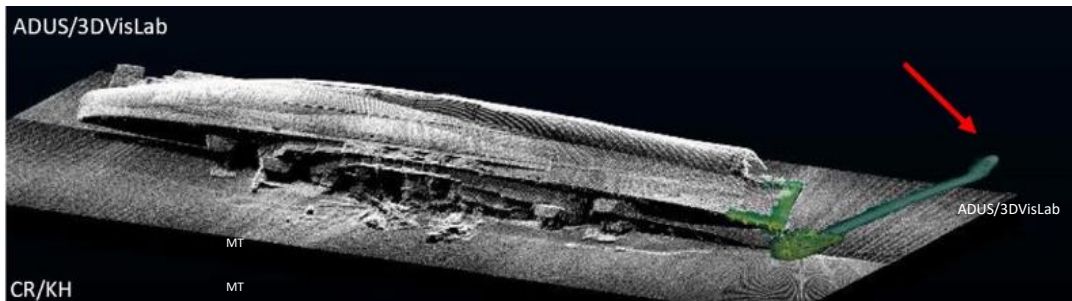
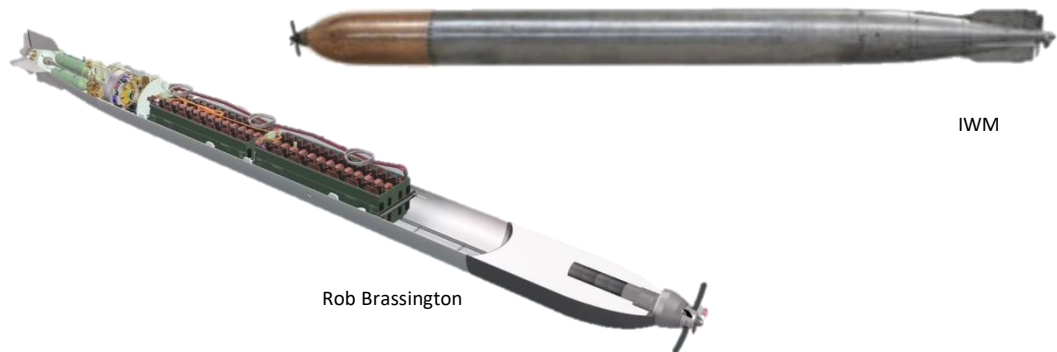
G7e/T2 Torpedo

The remains of a German G7e/T2 torpedo found ~60m NNW ROYAL OAK's bow.

Torpedo lies flat on the seabed, **no evidence of collision** with the ship or seabed, suggesting it missed ROYAL OAK and **sank to the seabed** at the end of it's run.

Steel casing, propeller and hydroplanes have **corroded** away, likely due to effects of **sea water** and leaking **battery acid**.

280kg Brass/Hexanite warhead & Firing Pistol, Bakelite lead-acid batteries, Stainless Steel motor & guidance section remain.

Small **scallop dredge** snagged on motor & guidance section.

Torpedo heading (~305°) and position (60m NNW of ROYAL OAK's bow) suggest it is the torpedo **fired from U47's stern tube** (second salvo). The range ~3000m is consistent with the maximum for G7e/T2 torpedo without pre-heat of the batteries.

- Warhead & firing pistol was removed and destroyed December 2019 by the Royal Navy Northern Diving Group.

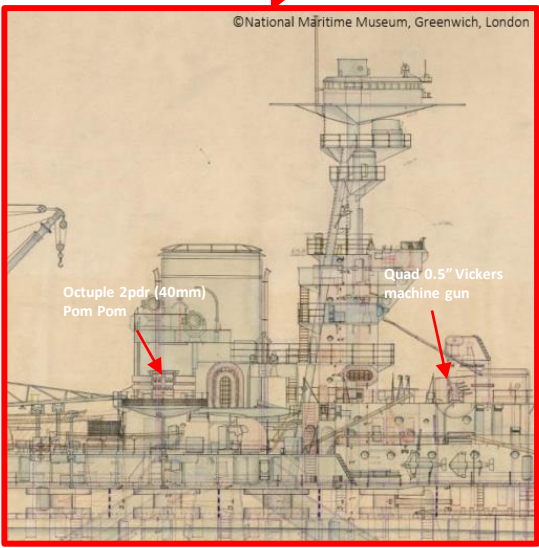
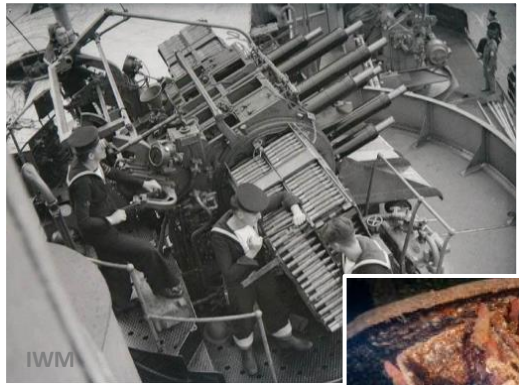
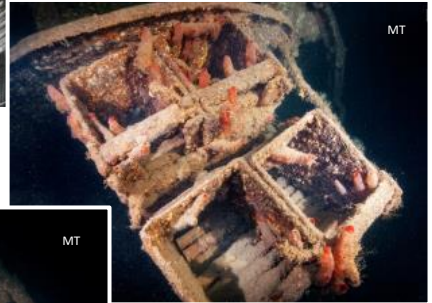
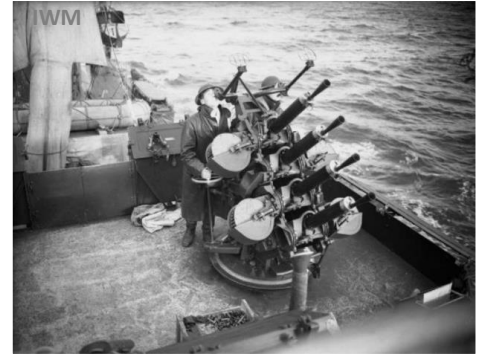
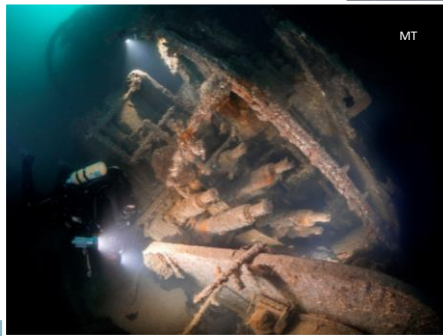
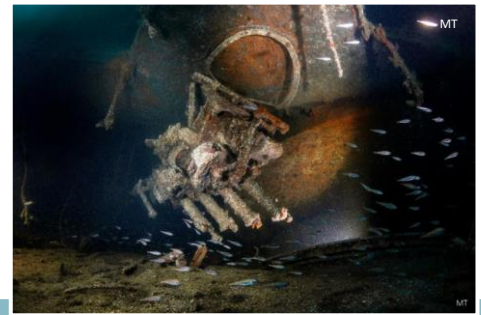
Octuple 2pdr (40mm) Pom Pom & Quad 0.5" Vickers Mk III Machine Gun

The **Pom-Pom** mount ammunition loading bins are virtually full, presumably in anticipation of an air raid.
The **Vickers** machine gun ammunition loading bins are empty, presumably because they would be quick to load and bring into action.

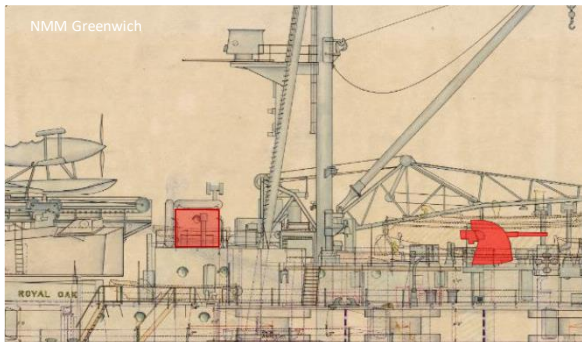
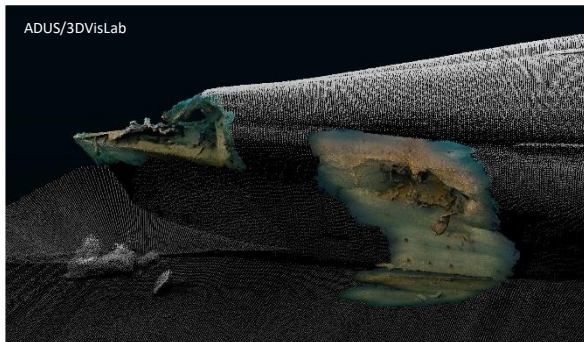
1. **Site of Torpedo Hit #2**, behind fractured and broken longitudinal armoured bulkhead protecting magazine on Platform deck. Ammunition boxes showed blast damage from torpedo strike, but exhibited no sign of ammunition fire or explosion.

Torpedo Hit #2 was virtually a direct hit on this magazine. It is remarkable that a magazine explosion did not occur. An **even greater tragedy was averted** because of the **resilience of the ammunition** to sympathetic reaction.

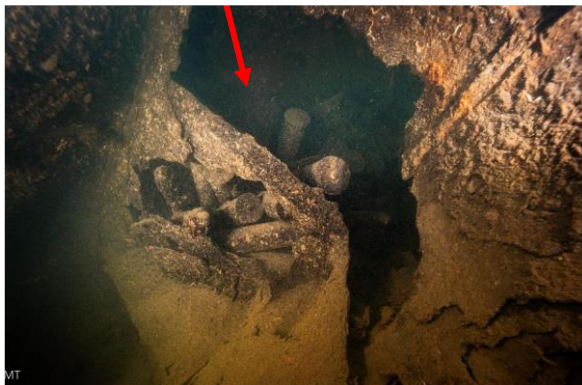
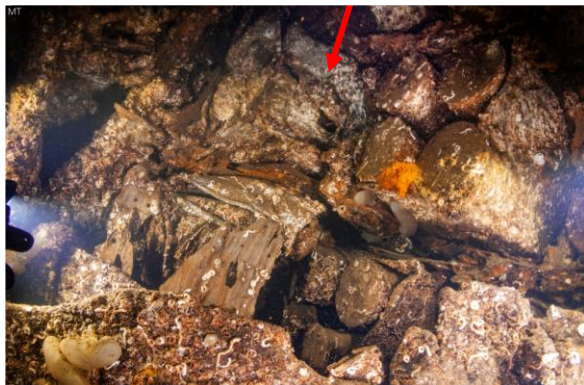
2. **Deck house on Shelter Deck**. Ammunition was unpacked and unrestrained. Likely this was **ready ammunition** temporarily stored near the gun mounts in anticipation of an air raid.

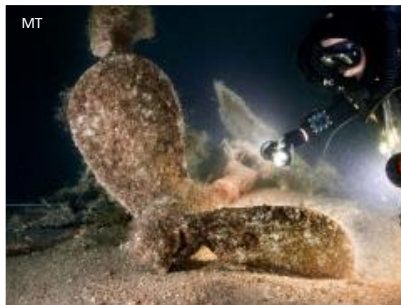
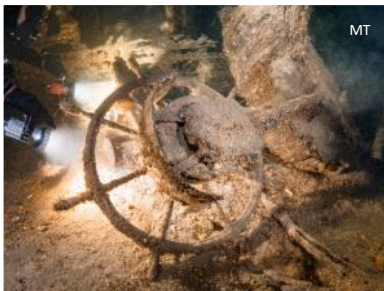
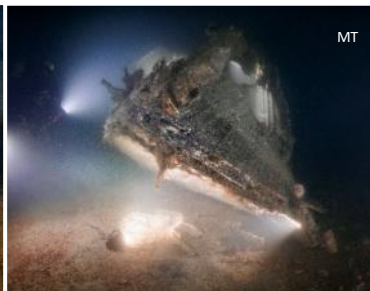
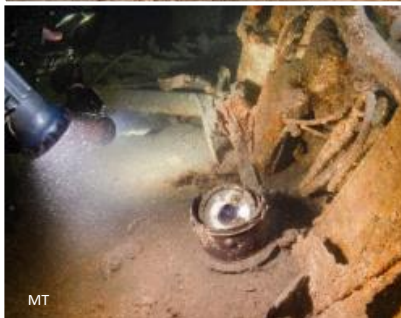
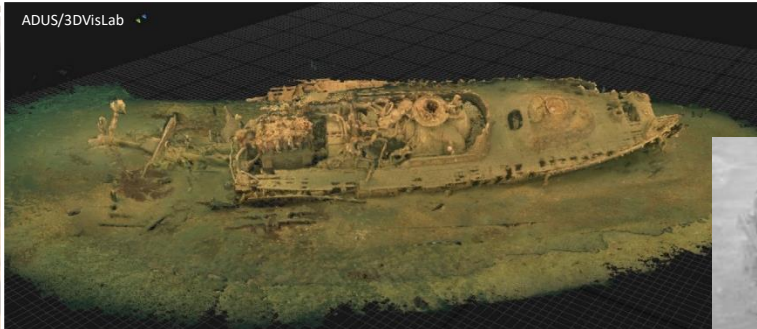
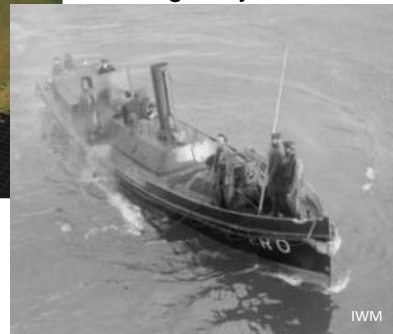
50' Steam Pinnace "jolly boat"

One Pinnace was crushed by the Mainmast as ROYAL OAK capsized and is located in the mid-ships debris field.

The second floated away with survivors aboard, but sank when overloaded, with significant loss of life. It has been found on the seabed to the west of ROYAL OAK. It is ostensibly intact, but damaged by trawl fishing.

The survey team has recommended that the exclusion zone around ROYAL OAK be extended to include this important site.
