HMS ROYAL OAK

HMS Royal Oak 80 Survey

**Ordnance, Munitions
& Torpedo Damage**

David Crofts MSc CEng FRAeS

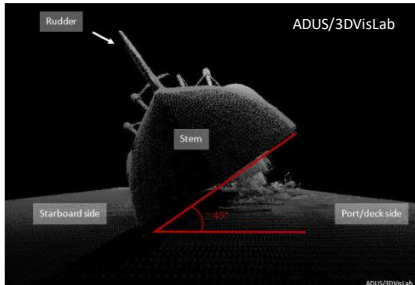
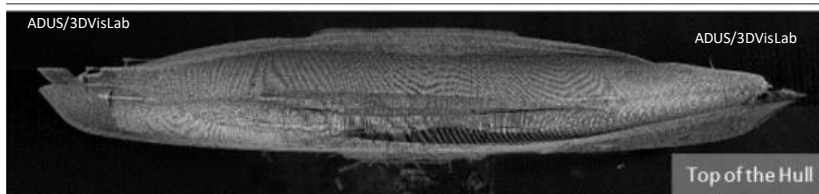
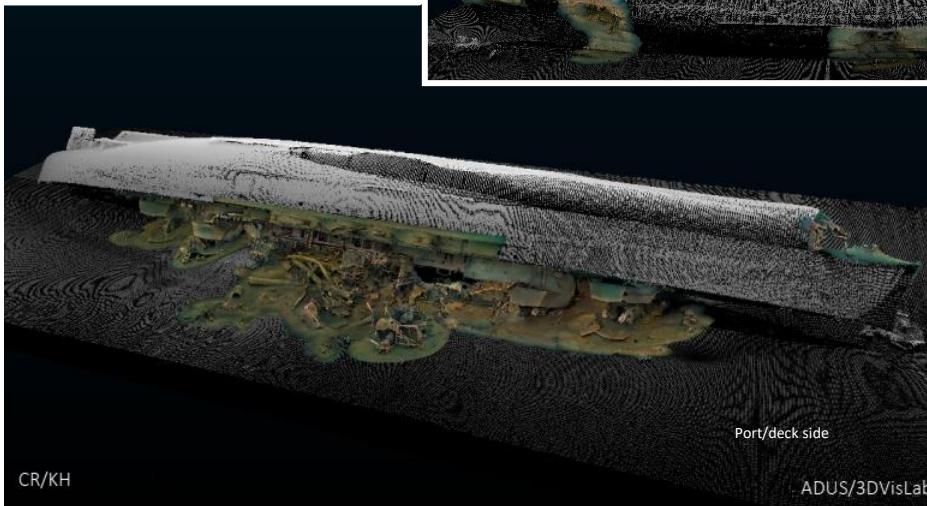
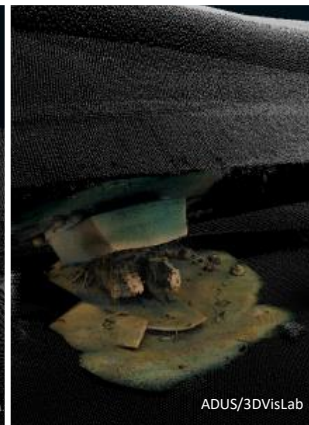
- HMS Royal Oak lies in the seabed of Scapa Bay, Scapa Flow, Orkney, upturned on her starboard rail, main deck at $\sim 45^\circ$ to the seabed in a water depth $\sim 34\text{m}$, $\sim 6\text{m}$ to the top of the hull.
Crushed superstructure keeps hull above the seabed.
Bow forefoot has fallen to the seabed due to torpedo damage.
Four torpedo holes clearly visible starboard side.
Masts and other debris lies on the seabed
Main gun turret roofs lie on seabed revealing gun breaches & interior of the turrets

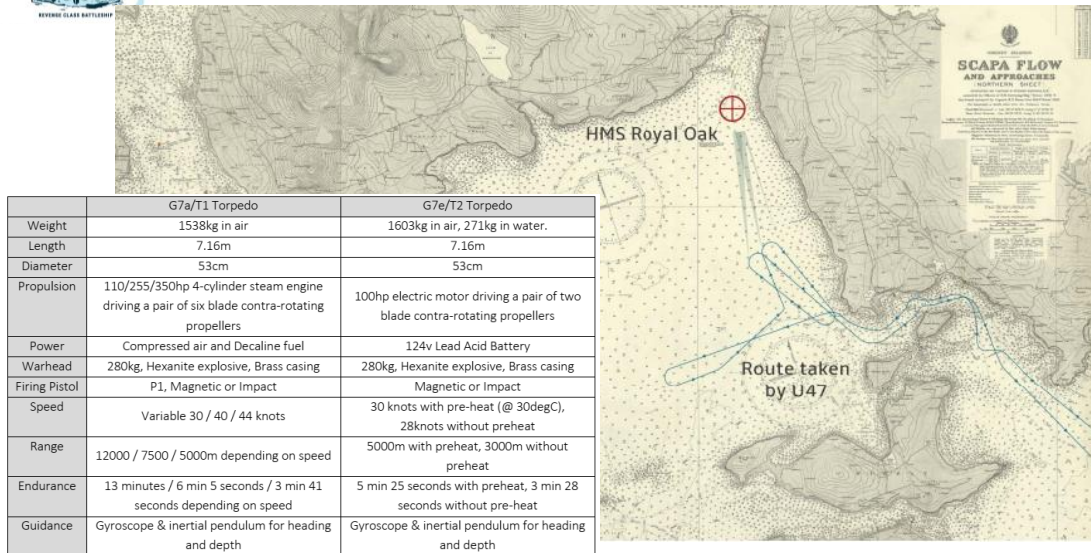
Seven torpedoes fired in three salvos

1. Three G7e/T2 torpedoes at 00:58 & ~3000m. One hit starboard side
Frame 10 (bow beneath anchor)
2. One G7e/T2 torpedo (stern tube) at 01:02. No hit.
3. Two G7e/T2 + One G7a/T1 torpedoes at ~01:08. Three Hits starboard side
Frame 27 (bow, beneath breakwater),
Frame 132 (beneath boat deck, boiler room 3)
Frame 208 (beneath mainmast, engine rooms).

In 1939 German torpedoes were unreliable.

They ran ~2m too deep & the magnetic firing pistols were unreliable.

To compensate, U47 fired torpedoes at shallow depth (3.5m setting, ~5.5m actual) and with impact pistols set.
